**DYNAMIC TESTING  
OF THE  
R1209 POWER TRANSFER SEAT**

MGA Reference No.: C12S3-023.1

**FINAL REPORT**

Procedure: ECE 74-408

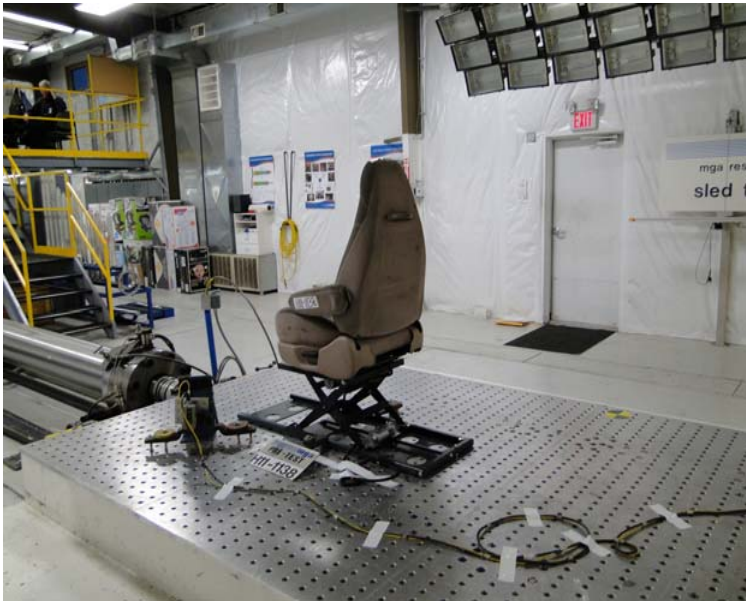
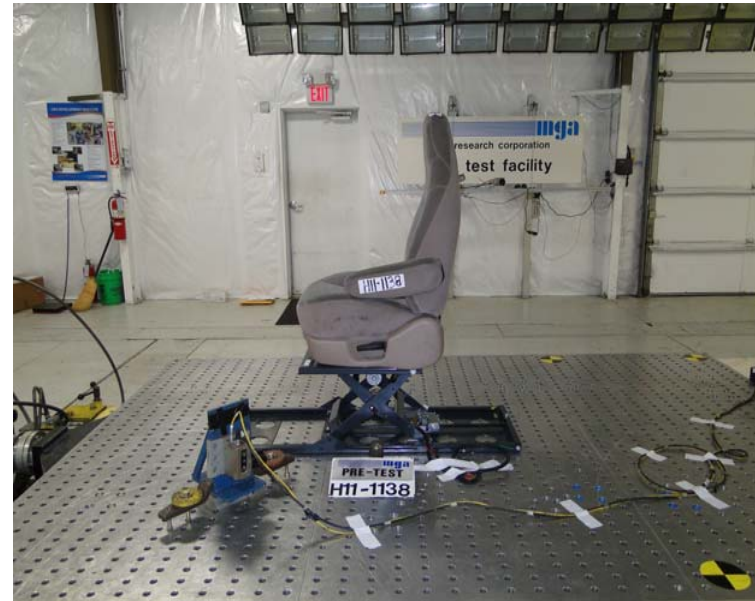
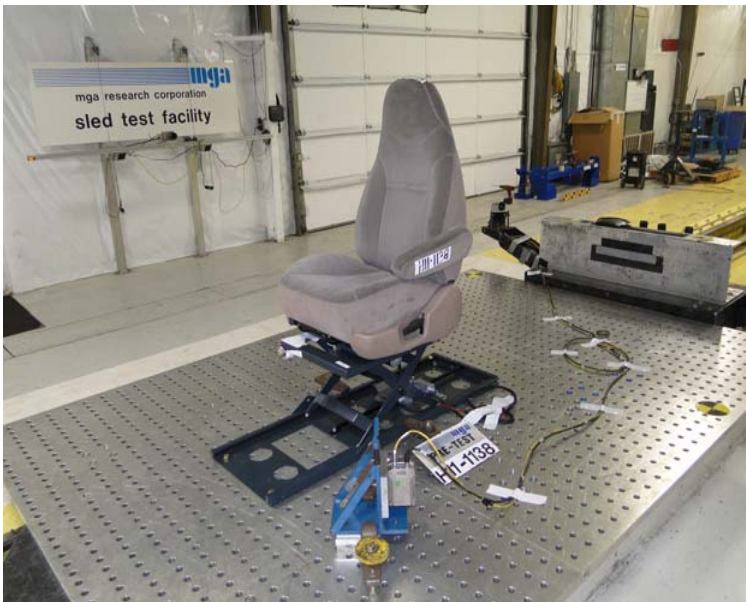
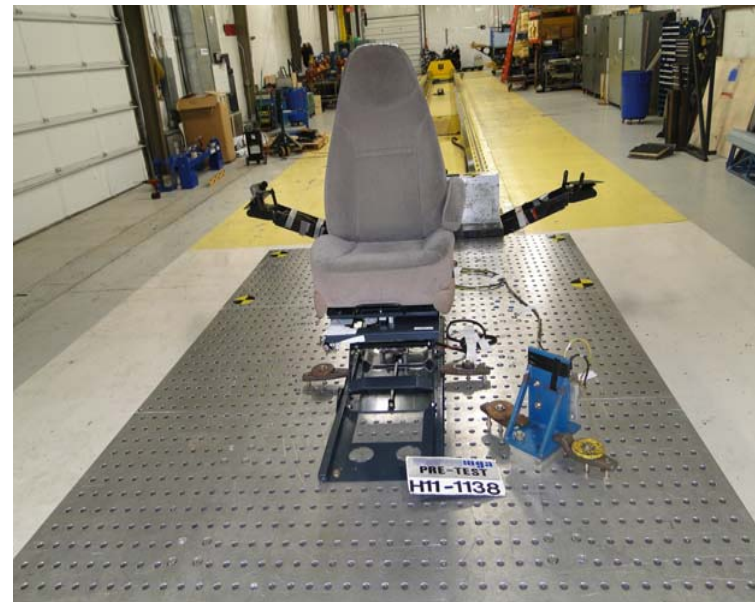
Sled Test: H111138

Pre-Test

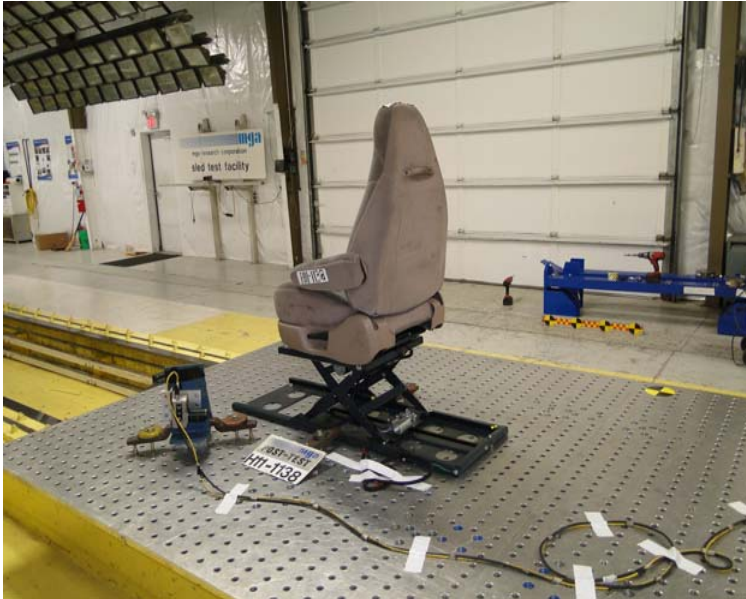
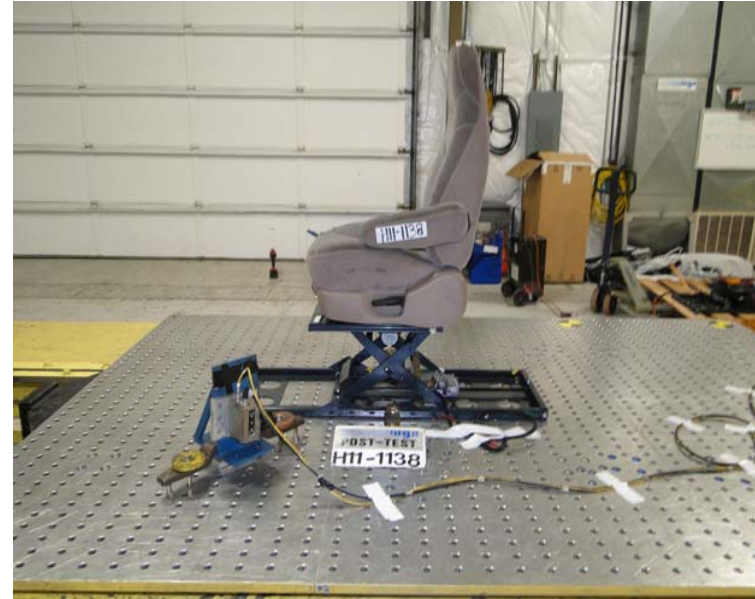
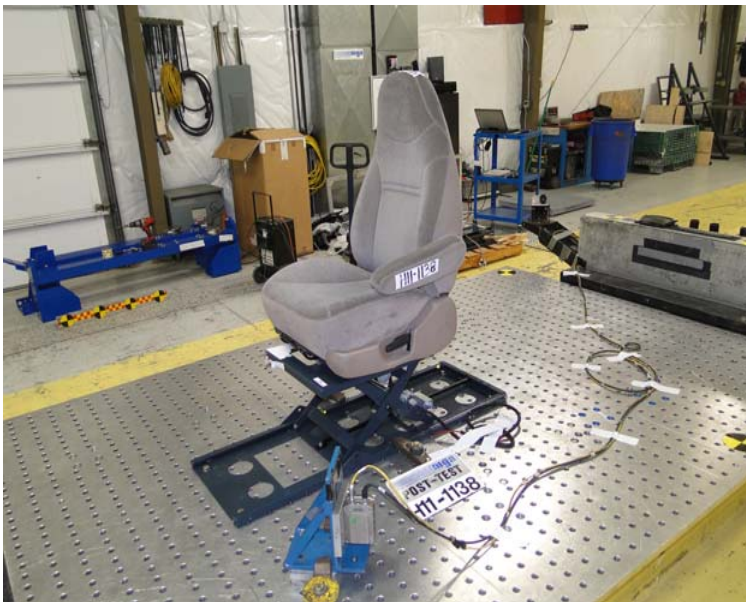
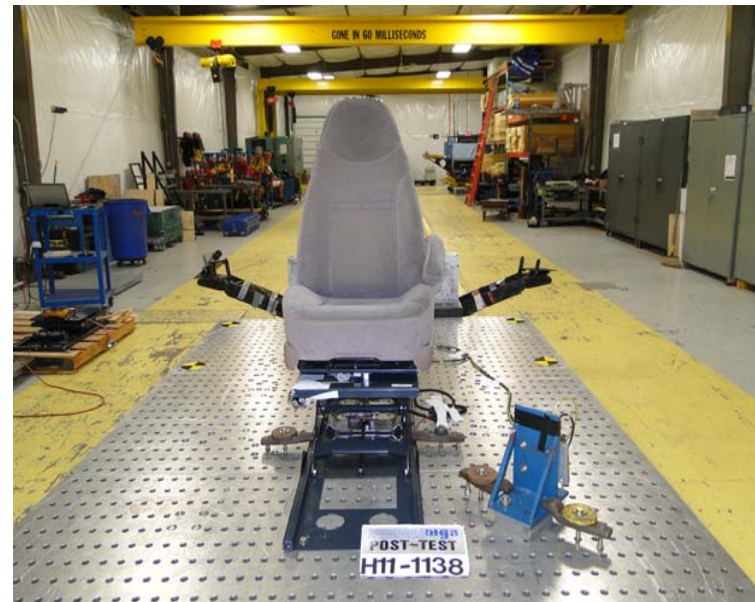
Sled Test: H111138

Post-Test

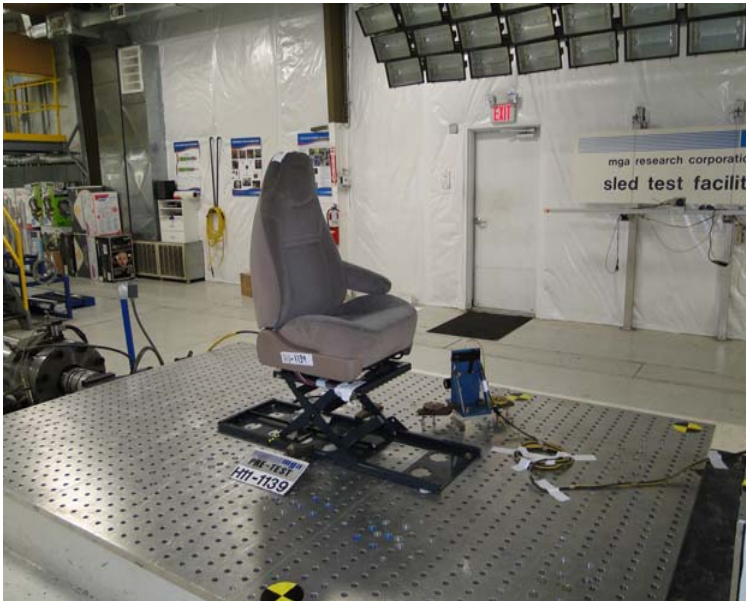
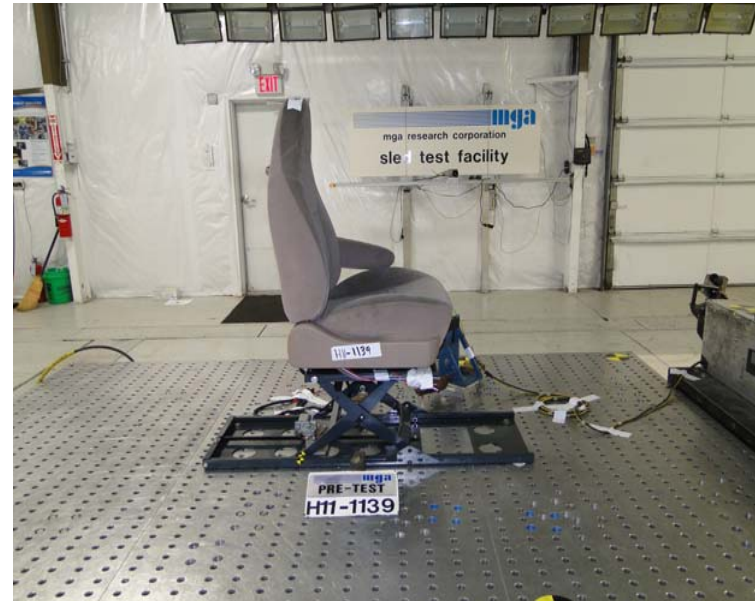
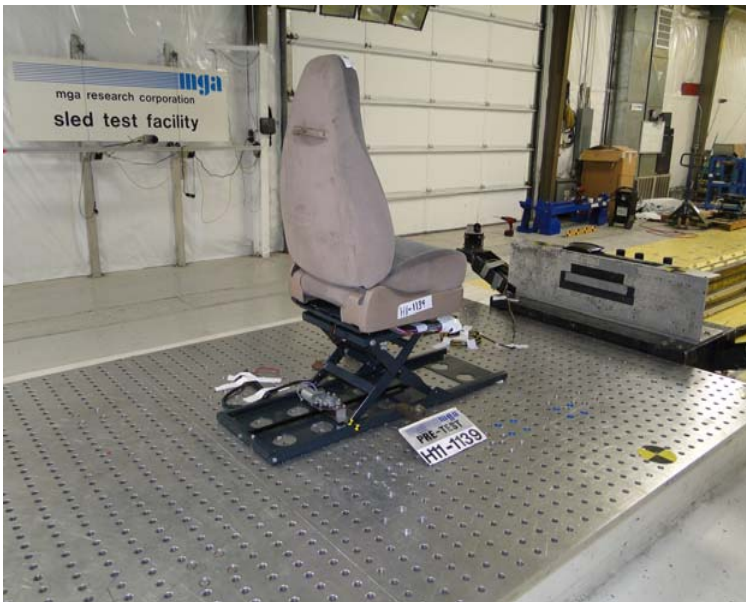
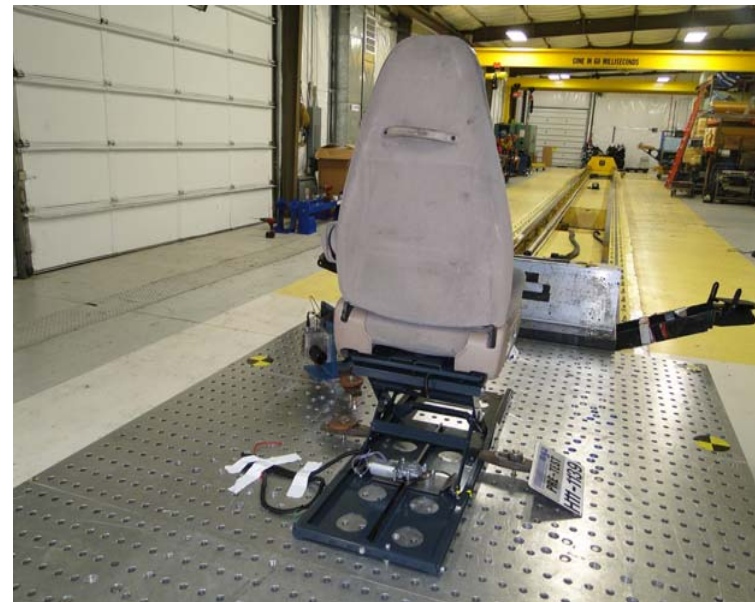
Sled Test: H111139

Pre-Test

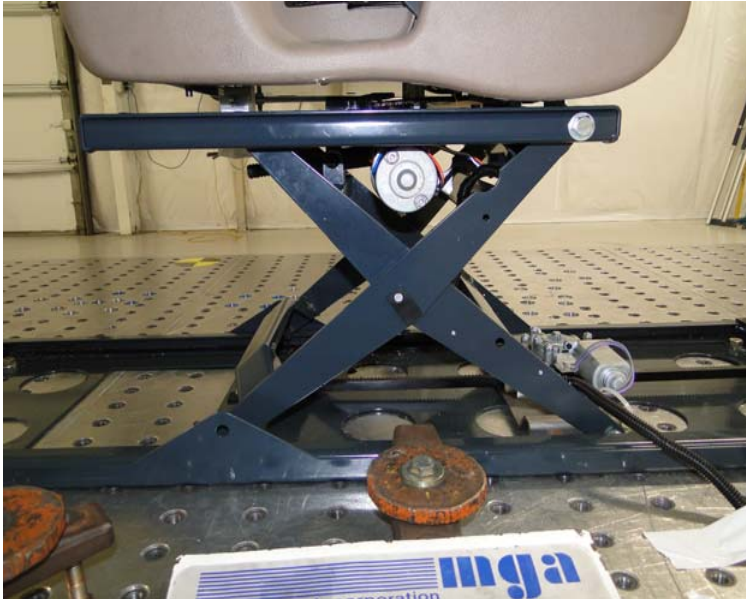
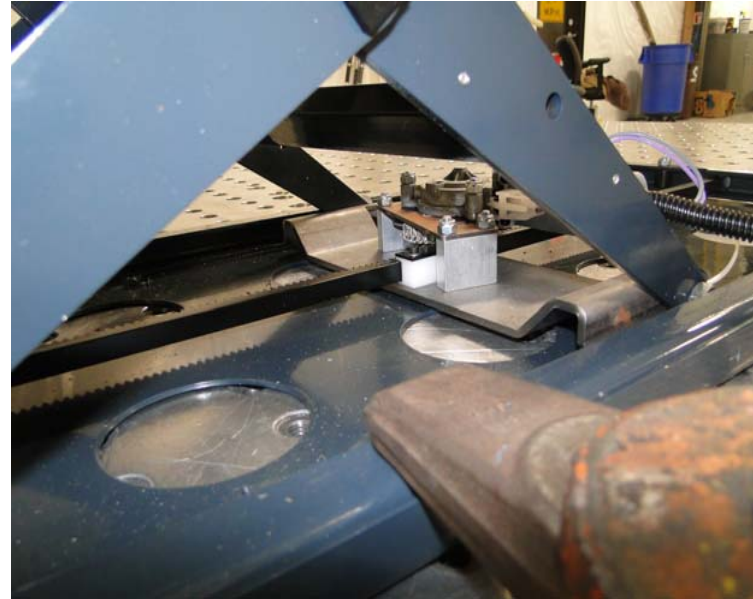
Sled Test: H111139

Pre-Test

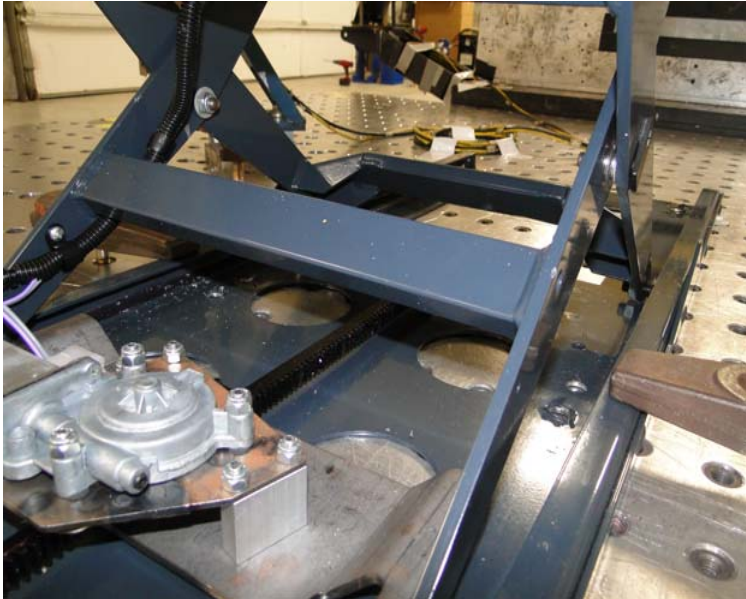
Sled Test: H111139

Post-Test

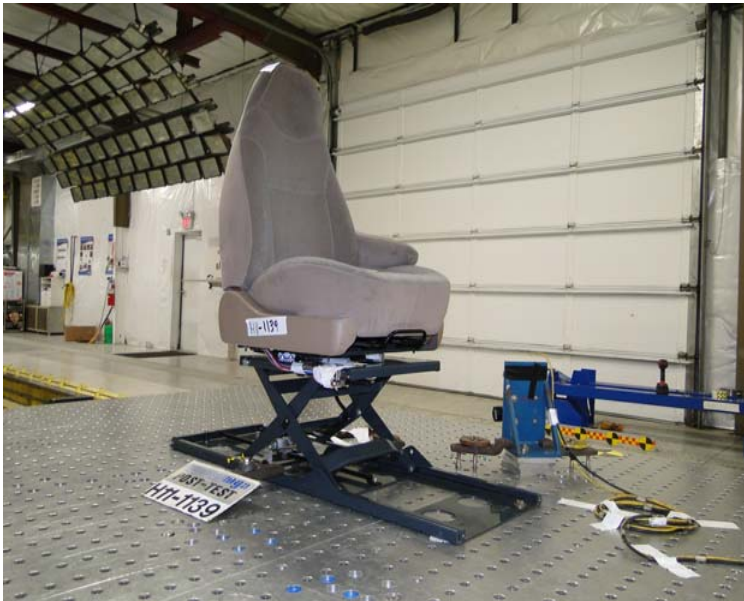
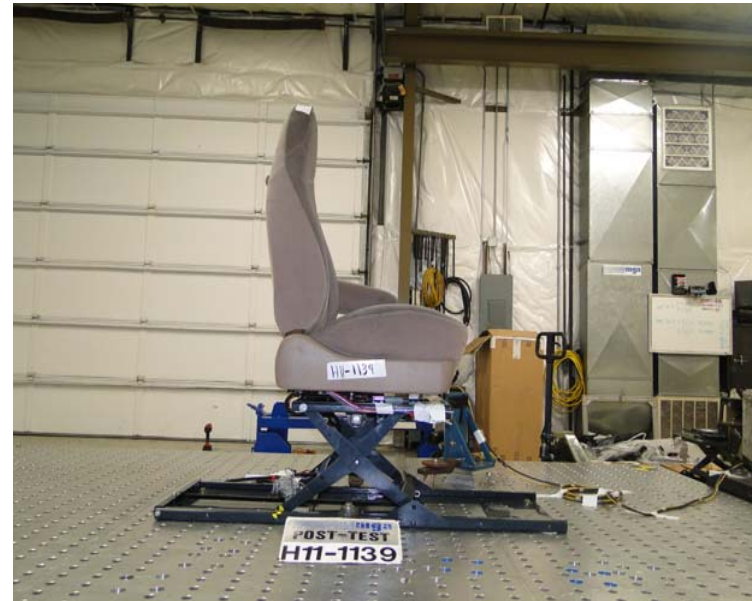
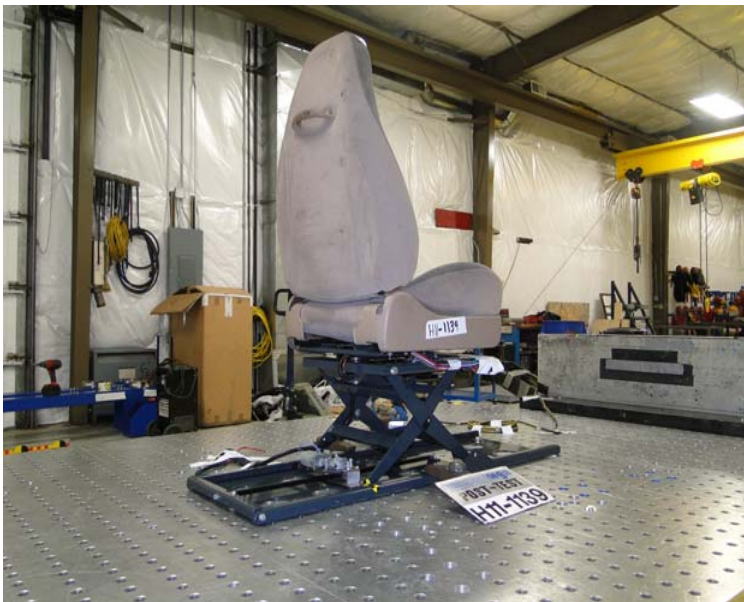
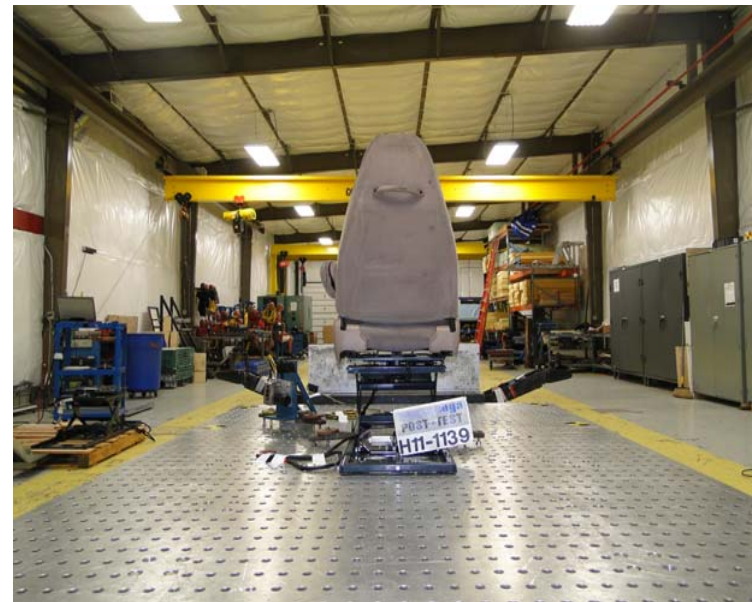
Sled Test: H111139

Post-Test
